# Former Wollongong Gasworks Remediation Project

Emission Control System & Vent – February 2021

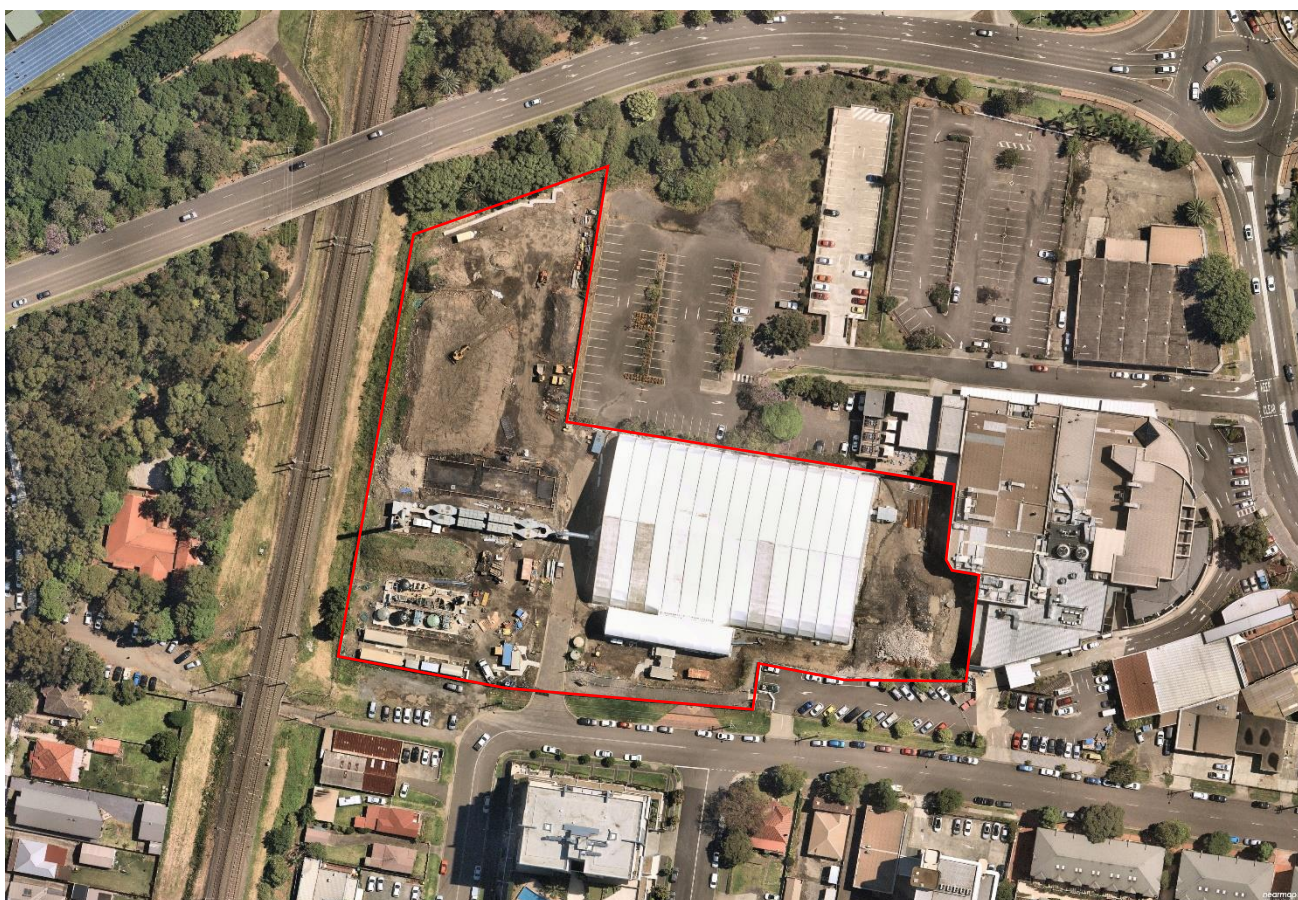
*Aerial image of the former Gasworks site (Dec 2020) showing the ECS structure in place (above in white) . Courtesy of Nearmap*

The Environmental Control Enclosure (ECE), designed to limit the impacts of work on the local community and environment, comprises the large tent like structure – which is supported by an Emission Control System (ECS) that maintains a safe environment for personnel undertaking remediation activities inside.

The ECE is constructed of steel trusses covered in a durable, weather-proof fabric. Truck loading locks adjoin the ECE to provide access for vehicles loading. The doors are automatic and include air curtains to minimize dust, odour and emissions escaping from the structure.
